Manhole Inspection Summary

Manhole # **S11GG1026MH**

Insp Date: **5/18/09 9:36 AM**

Location Address: **2812 W COLD SPRING LN** Cross Street: **TOWANDA AVE**

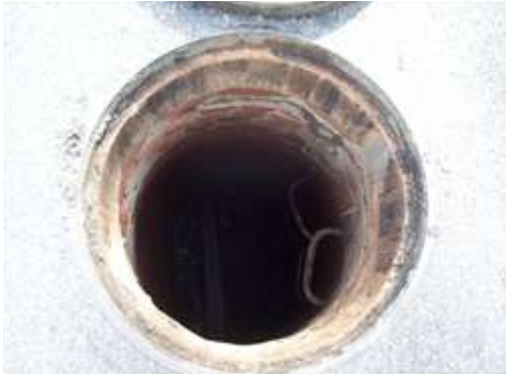
Top View

Frame Offset: **1** (in.) Condition: ☒ Sound ☐ Cracked ☐ Leaks

FRAME OFFSET

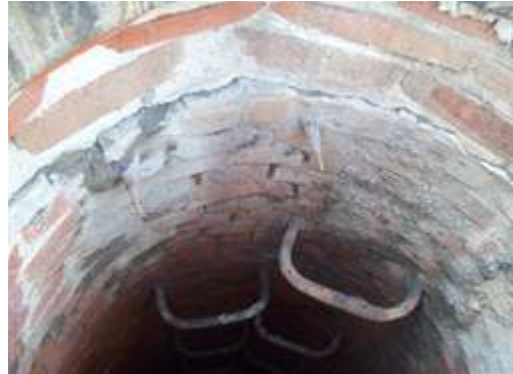
Defect 1

Steps Count: **9** Missing: **1** ☐ Corroded

MISSING STEP

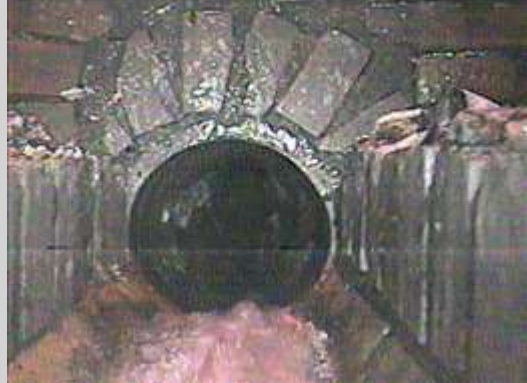
12 O'Clock Outflow

8 in. Circular Gravity Sewer
Pipe Out @ 12 O'Clock

Pipe Height: (in.) Direct
Pipe Material: **PVC** ☐ Pipe Lined
Invert Depth: **13.24** (ft.) Flow Characteristics: **Fast**
Deposits: ☒ None ☐ Mud ☐ Sludge ☐ Debris ☐ Grease
Silt Depth: (in.) Deposits Extent:
Infiltration: **None** Pipe Seal Cond: **Sound**

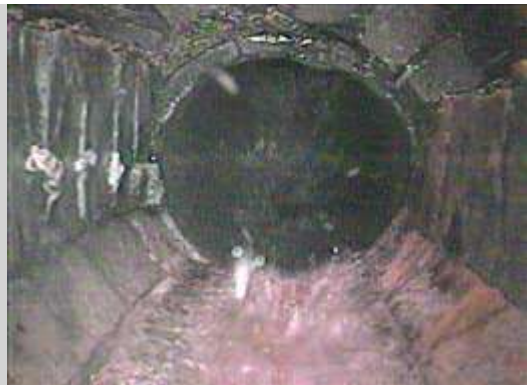
6 O'Clock Inflow

8 in. Circular Gravity Sewer
Pipe In @ 6 O'Clock

Pipe Height: (in.) Direct
Pipe Material: **PVC** ☐ Pipe Lined
Invert Depth: **13.14** (ft.) Flow Characteristics: **Slow**
Deposits: ☒ None ☐ Mud ☐ Sludge ☐ Debris ☐ Grease
Silt Depth: (in.) Deposits Extent:
Infiltration: **None** Pipe Seal Cond: **Sound**
